TO: Development Review Board  
FROM: William Ward, Director of Code Enforcement  
DATE: October 4, 2011  
RE: 12-0265AP; 25 Orchard Terrace Appeal of - Zoning Violation # 217132

**Request:** Appeal of Notice of Violation issued by Code Enforcement Office

**Location:** 25 Orchard Terrace Burlington, Vermont

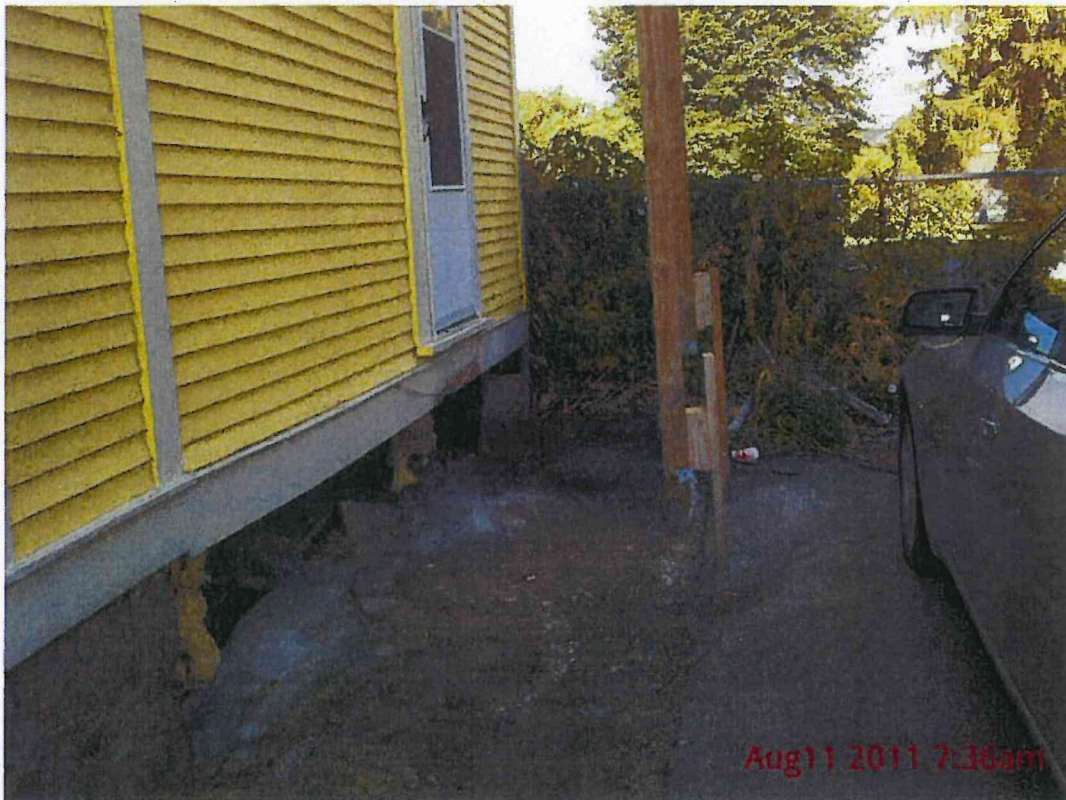
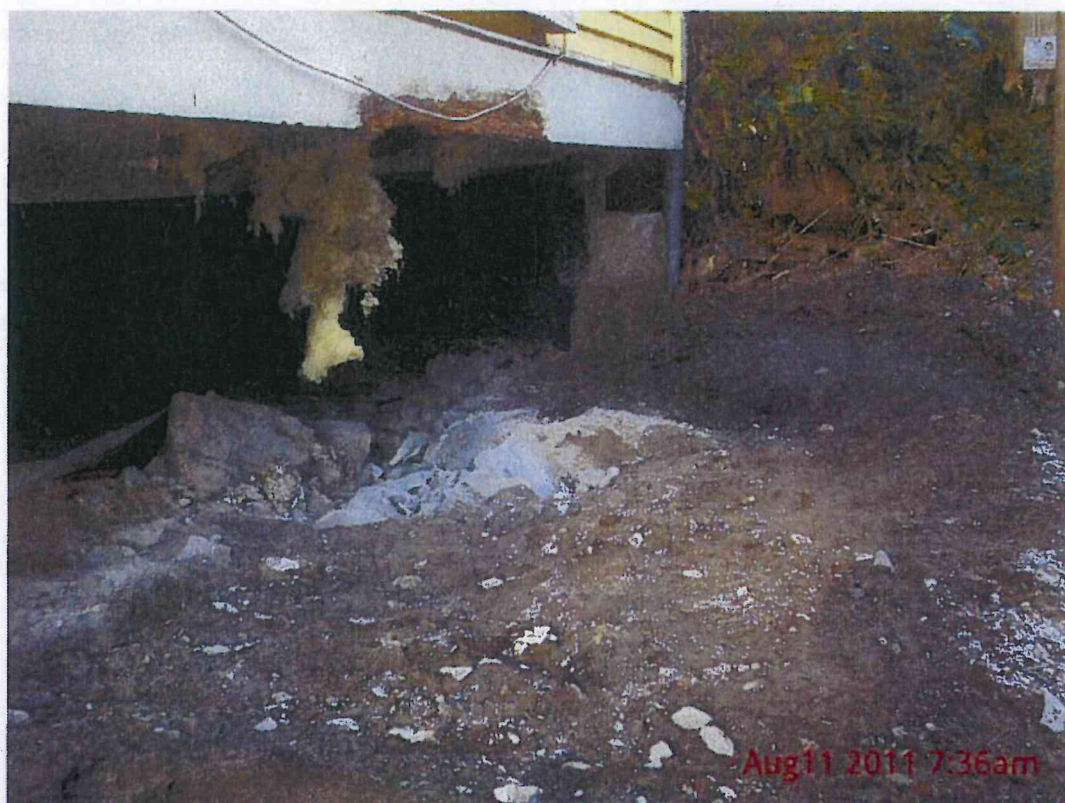
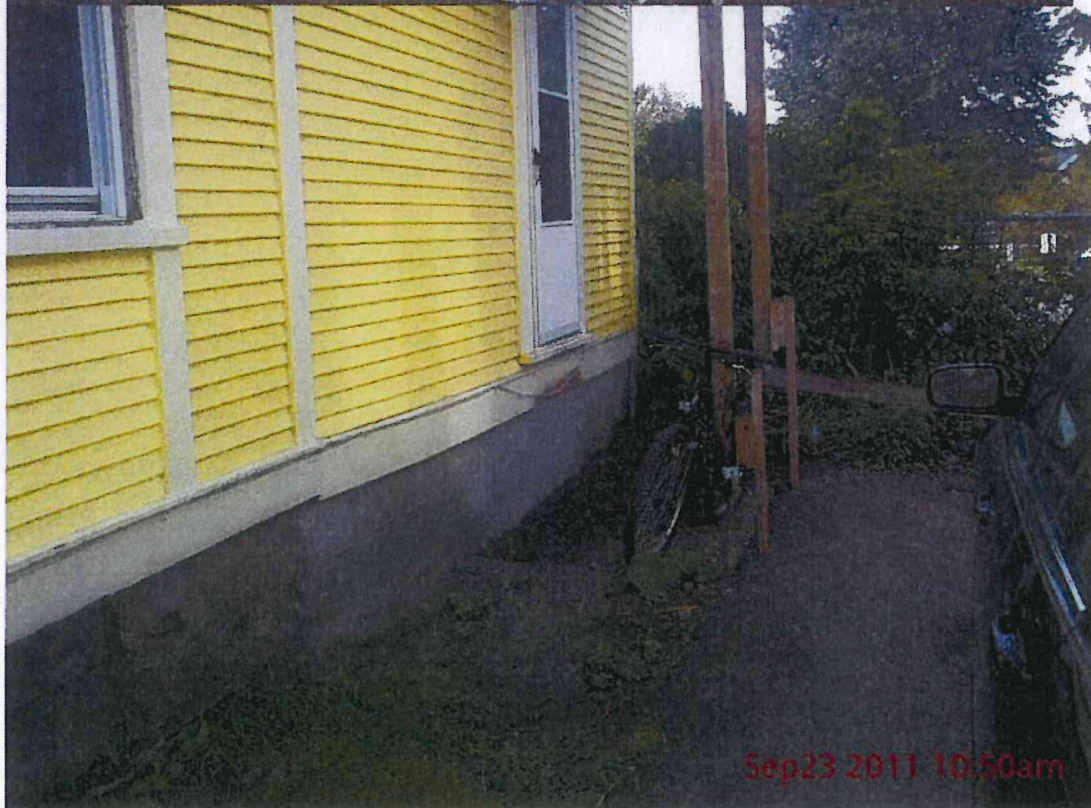
- On August 10, 2011 it was noted that the cement staircase and north porch of 25 Orchard Terrace had been removed from the building and were no longer located on the property. In addition, a section of foundation wall had been removed and no zoning or building permits were visible on the property. A record check of the City's Amanda permit data base confirmed that no zoning or building permits were applied for or issued for the project.

- The Code Enforcement photos of the construction area on August 11, 2011 show a Redstone foundation with a 14 foot long, 2 foot high gap in the foundation where the porch and steps once connected to the building. Code Enforcement photos on September 23, 2011 show a newly constructed cinderblock foundation filling the 14' by 2' gap.

Uphold the decision to issue a Stop Work Order and Notice of Violation for removal of stairs and side porch of historic structure. Order the owners to obtain zoning permit approval for exterior work and that the any such work shall be in a manner consistent with CDO regulations particularly that all work be appropriate to the historic character of the structure as per Sec. 5.4.8.
